# Manhole Inspection Summary

Manhole # S06GG2010MH

Insp Date: **7/29/06 8:32 AM**

**Location** Address: **3401 BONNIE RD**

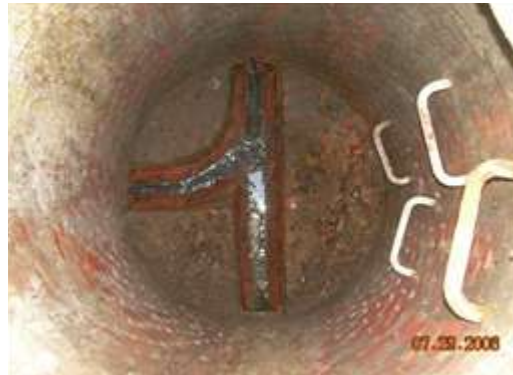
Top View

Evidence of surcharge - Bench debris.

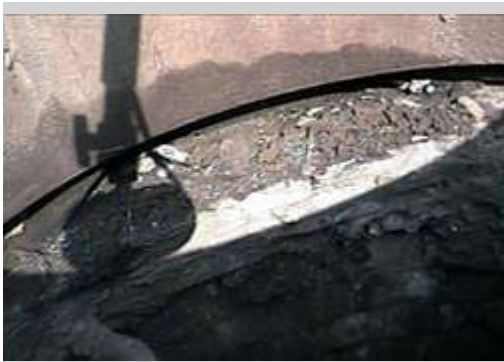
Defect

☒ **Leaks**

Condition: ☐ Sound ☐ Cracked ☐ Root Intrusion ☐ Loose Brick ☒ **Deteriorated**

Infiltration: ☐ None ☒ **Joint** ☐ Cracks ☒ **Mortar** ☐ Roots ☐ Wall

Frame leaks. Adjustment and Corbel deterioration and infiltration.

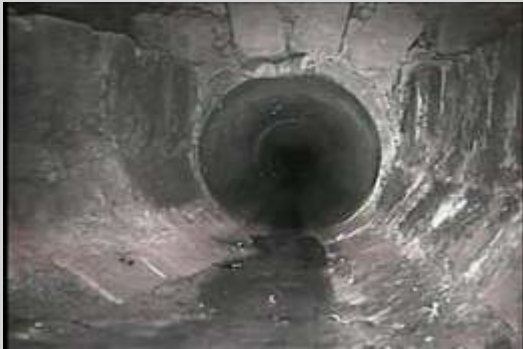
### 8 in. Circular Gravity Sewer Pipe Out @ 12 O'Clock

Barrel deterioration and infiltration.

Infiltration: **Evidence** Pipe Seal Cond: **Unknown**

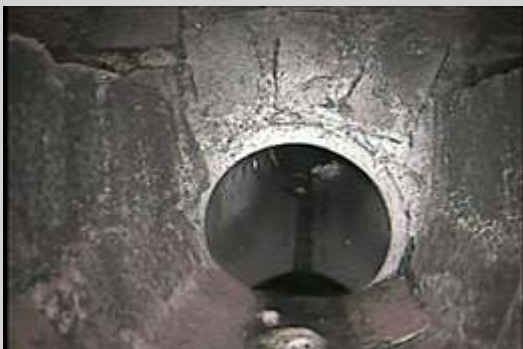
### 8 in. Circular Gravity Sewer Pipe In @ 6 O'Clock

Infiltration: **Evidence** Pipe Seal Cond: **Cracked**

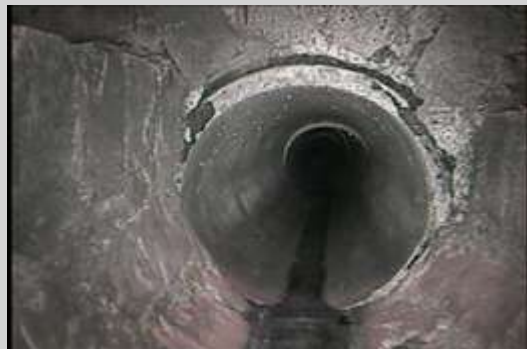
Pipe In @ 9 O'Clock

Infiltration: **Evidence**
